MEASUREMENT OF FLYING QUALITIES OF A DOUGLAS A-26B AIRPLANE

(AAF No. 41-39120)

III - STALLING CHARACTERISTICS

By S. A. Sjöberg, H. L. Crane, and H. H. Hoover

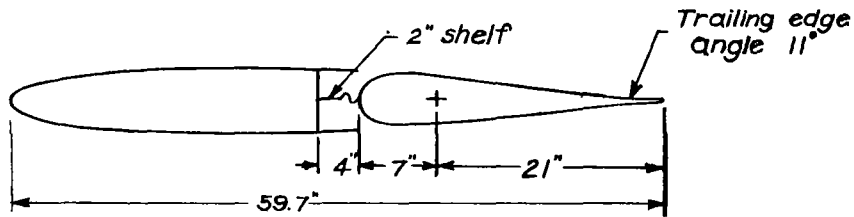
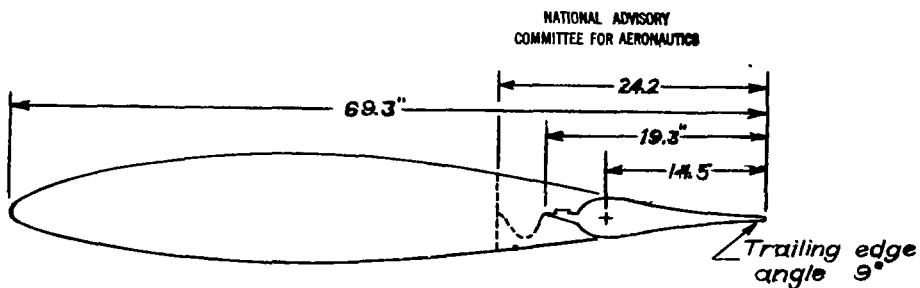
Figure 1.- Concluded.

Section vertical tail 49 inches from tip

Section of horizontal tail 76.5 inches from airplane center line

Wing section 352 inches from airplane center line

(b) Sections through vertical tail, horizontal tail, and wing at aileron. Douglas A-26B airplane.

Figure 1 shows a three-view drawing of the airplane and sections of the wing and tail surfaces. A description of the airplane and several photographs of the airplane are given in reference 1. Figure 2 presents photographs of the wing surface condition and the oil-cooler air intake. Figure 3 is a side-view photograph of the airplane showing the location of the service airspeed head. The airplane was equipped with double-slotted flaps. Figure 4 shows a section of the flap at various deflections.

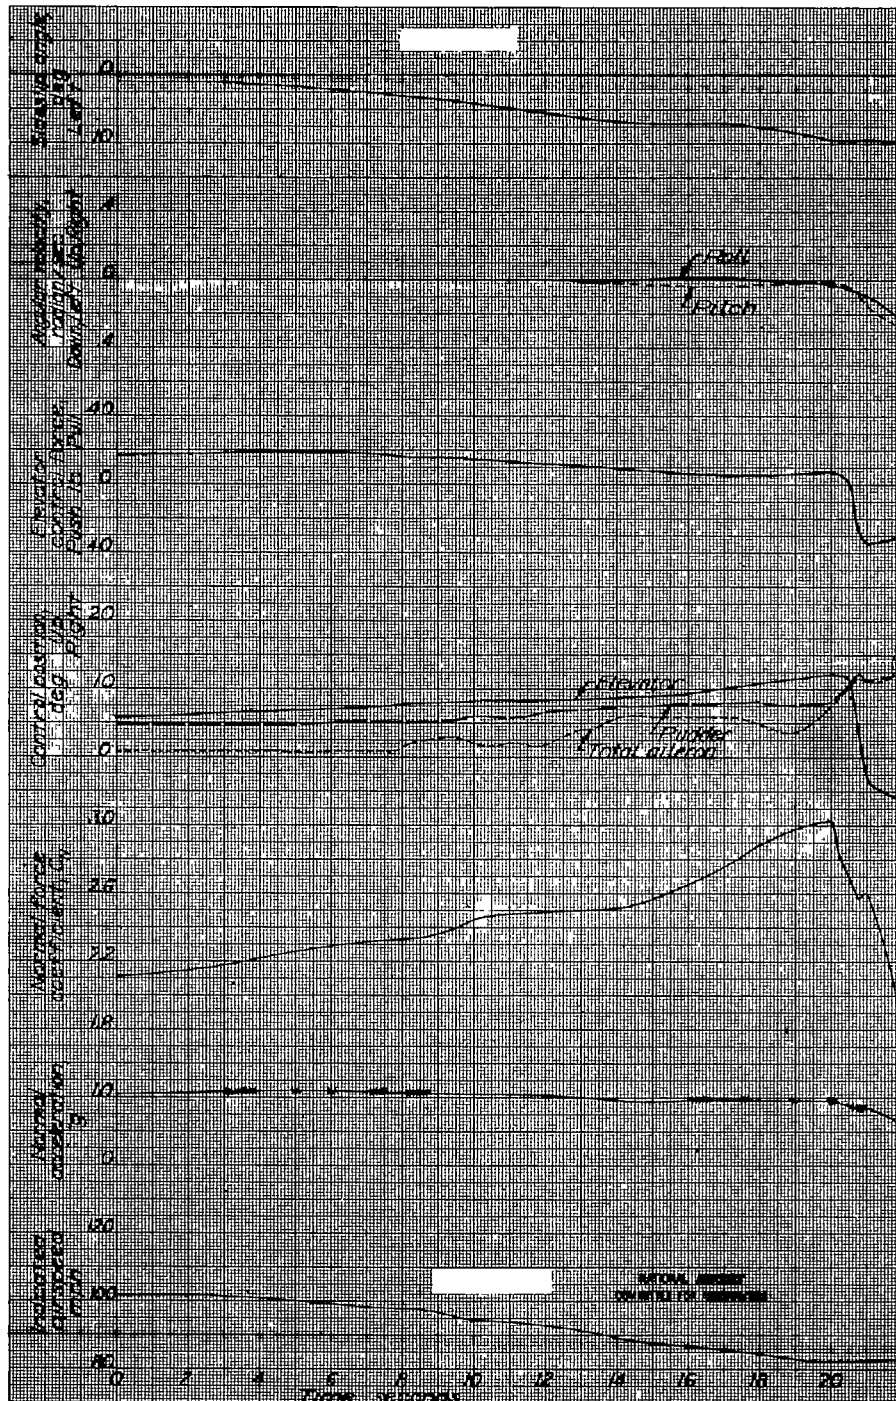
Figure 8.- Time history of a stall in the wave-off condition (41.5 in. Hg. at 2400 rpm, flaps down, landing gear down, cowl flaps open, oil cooler one-half open, c.g. at 23 percent M A C), Douglas A-26B airplane.

The straight-flight stalling characteristics were investigated in the rated power-clean, cruising, gliding, approach, landing, wave-off, and take-off conditions. The stalls were made by gradually reducing the airspeed while attempting to hold straight flight. Figures 5 through 8 are time histories of stalls in the rated power-clean, gliding, landing, and wave-off conditions. Figures 9, 10, and 11 are tuft studies showing the stall progression over the wing in the gliding and landing conditions, and in the flaps-up condition with one propeller feathered and the other engine delivering rated power. The reason for including a tuft study with one propeller feathered was to make possible a comparison with wind-tunnel studies of stalling over the lip of the wing duct which were made with propellers removed. Tuft studies were not made with power on, because the A-26B airplane climbed away from the observing airplane in the stall approaches.
